SERVICE BULLETIN

Number: SB0213

Subject: Prowler Control Arms

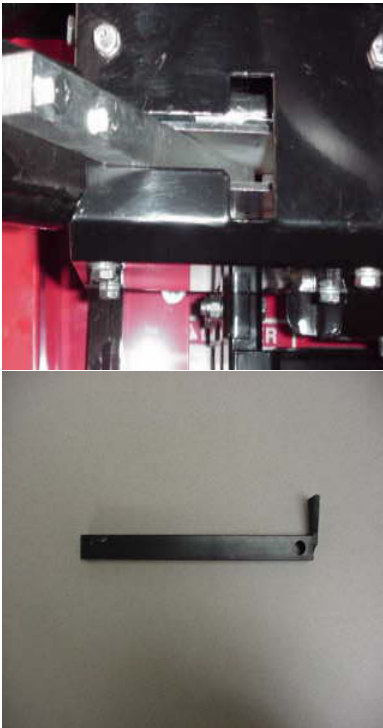
Prowlers with the T-box style steering, serial #'s 41004 to 43650, may not have a steering lever "block" thus allowing premature wear to the control box assembly. This may be remedied by adding part # 583191 to the control box assy. or by simply replacing the complete handle bar (part # 592060, refer to drawing).

OPTION 1:

Install 1" plug (part # 583191) by pushing it into the control box assy. on the inside of the control arm.

OPTION 2:

The complete handle bar may be changed to upgrade to the new style by ordering part #592060 for a quantity of 2. Encore will allow .25 hrs per side if replacing the handle bar. The bar can be replaced through the bottom side of control box assy. by removing the retaining bolt, slide new handle bar into place and re-bolt control box assy.
