SERVICE BULLETIN

Number: SB0404

Subject: 72" Deck Idler Replacement

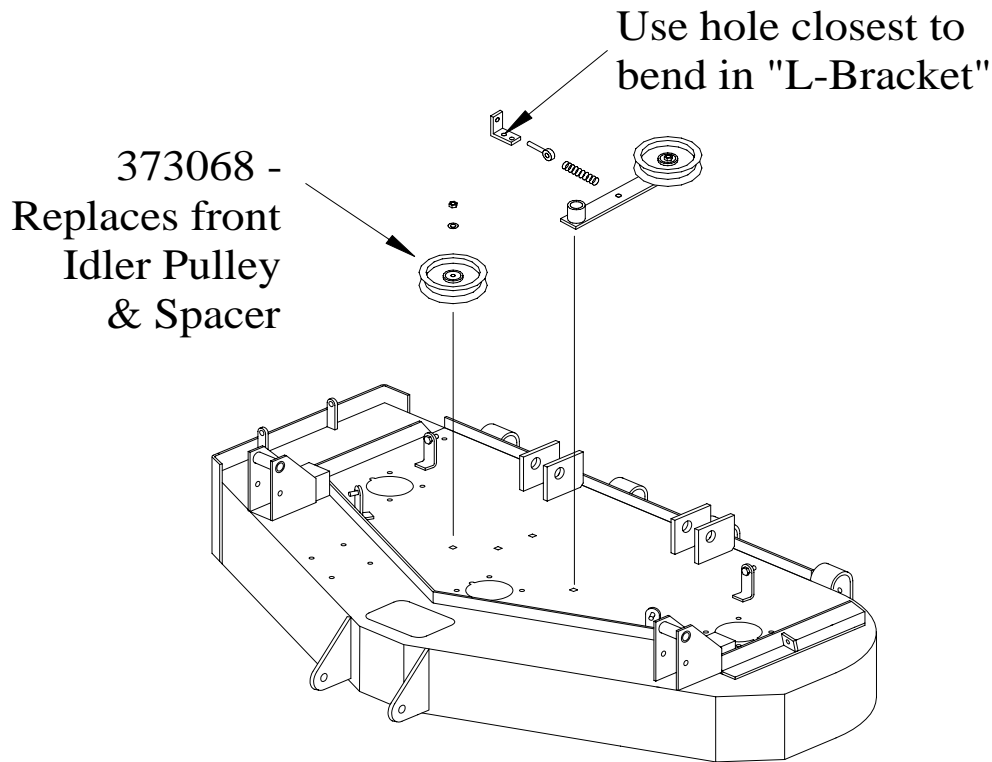
Details: It has been discovered on some 72" Prowler Midcuts that the tensioner pulley on the deck may come into contact with the frame rail when mowing in the upper cutting height settings.

This condition can be corrected by removing the existing front stationary idler (583162) and spacer (483017) and replacing them with an alternative idler pulley - part # 373068. You will re-use the existing bolt for fastening the replacement idler pulley (373068) to the deck.

By installing the replacement idler pulley, the distance of the belt route is shortened significantly. This will allow slack in the belt. Therefore, to remove the slack in the belt, the black "L-bracket" to which the tensioner spring and eye-bolt fasten to will need to be repositioned. As shown in the illustration below, turn the "L-bracket" 180 degrees and re-fasten to the deck using the hole in the "L-bracket" closest to the bend. Re-attach the tensioner spring and eye-bolt to the L-bracket.
