SERVICE BULLETIN

Number: SB0501

Subject: PARKER 10CC PUMPS ON MODEL # 52K23X SERIAL # 51298 AND BELOW

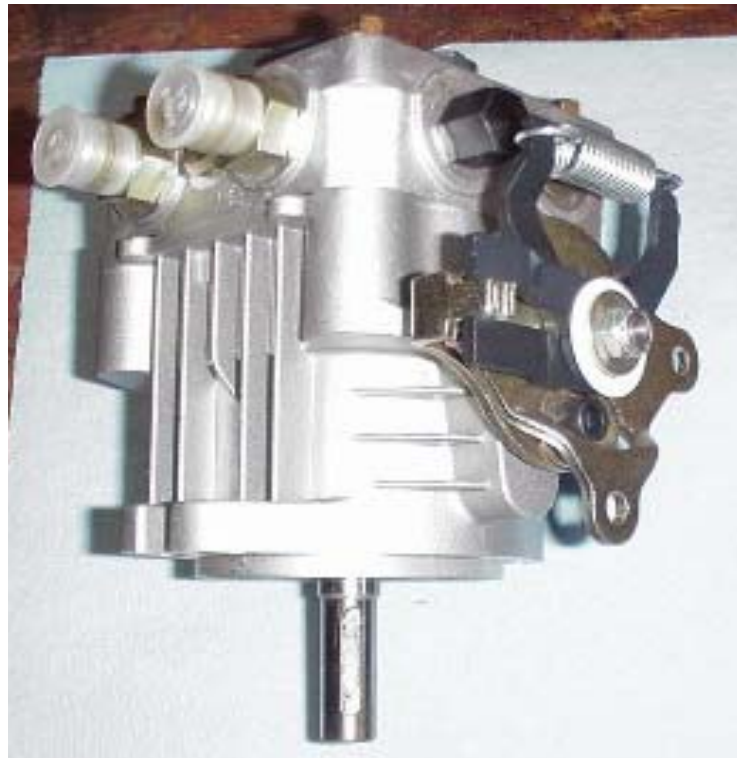
Details: Parker Hydraulics has notified Encore Mfg of an assembly error with regard to their 10cc hydraulic pump. The 5/16-24 Nyloc Nut that fastens the RTN (Return to Neutral) Assembly to the side of the pump was not properly torqued when assembled at the Parker factory. The torque spec is 8-10 ft-lbs.

Refer to photo below for location of Nyloc Nut and RTN Assembly.

Due to the position of the pump on the lawnmower, it may not be possible to apply a torque wrench onto the nyloc nut that fastens the RTN Assembly to the pump. In this case, a 1/2" open-ended wrench will be required to tighten the nut so that a slight amount of the stud is exposed through the top of the nyloc nut. This will ensure that the nyloc has been engaged onto the threaded stud.

This procedure must be performed to prevent the RTN Assembly from coming loose during operation. Please notify all 52K23X owners with serial # 's 51298 and below to take their machines to their dealers immediately to verify the torque of the nyloc nut.
