SERVICE NOTICE

Number: SN0307

Subject: X-treme 48, 52 and 60 unit below serial # 53686.

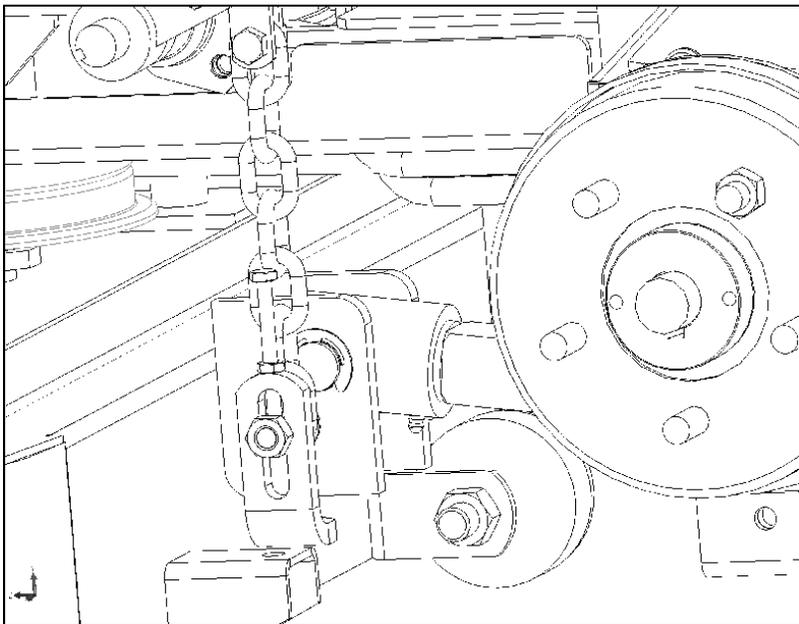
Details: When encountering hose damage on the X-treme Model you may remedy the problem by trimming the stand offs that are located to the rear of the deck. To do this raise the rear of the machine, making sure that it is secure, At this time remove the belt cover from the right hand side of the deck and roll the deck drive belt off of the spindle pulley. Now remove the rear tires and starting on the trim side or left hand side of machine from operators position remove the deck lift chain by removing the 3/8 bolt from the deck chain bracket. After doing this remove the straight grease fitting from the deck arm and replace it with the 90° grease fitting that is located in the rear of the of the deck lift arm tube assembly (just swap fittings). With that done now remove the cutter key from the support pin on the deck. Remove the pin and block the deck arm up, with a 4" grinder either cut or grind both deck arm stand offs to a 3/4" / 45° angle. After accomplishing this rotate the 90° grease fitting to the bottom side of the deck arm and replace the pin and cotter key. Reattach the deck chain bracket and repeat the procedure on the right hand side.

Replace the deck belt making sure the it is on all pulleys correctly, belt cover and replace the wheels.

If any hoses need to be replace please use part # 533089 outside and # 533090 inside lines. Note that hoses should be replaced while the wheels are removed.
