# SERVICE BULLETIN

WORLDLAWN POWER EQUIPMENT, INC.  
2415 Ashland Ave  
Beatrice, NE 68310  
(402) 228-4255

Bulletin Number: SB1404  
Date: 5/30/14

Product Affected: EC52FX730V3, EC52FX730V5, EC60FX730V3 & EC60FX801V5 mowers with serial numbers 61401 to 61420

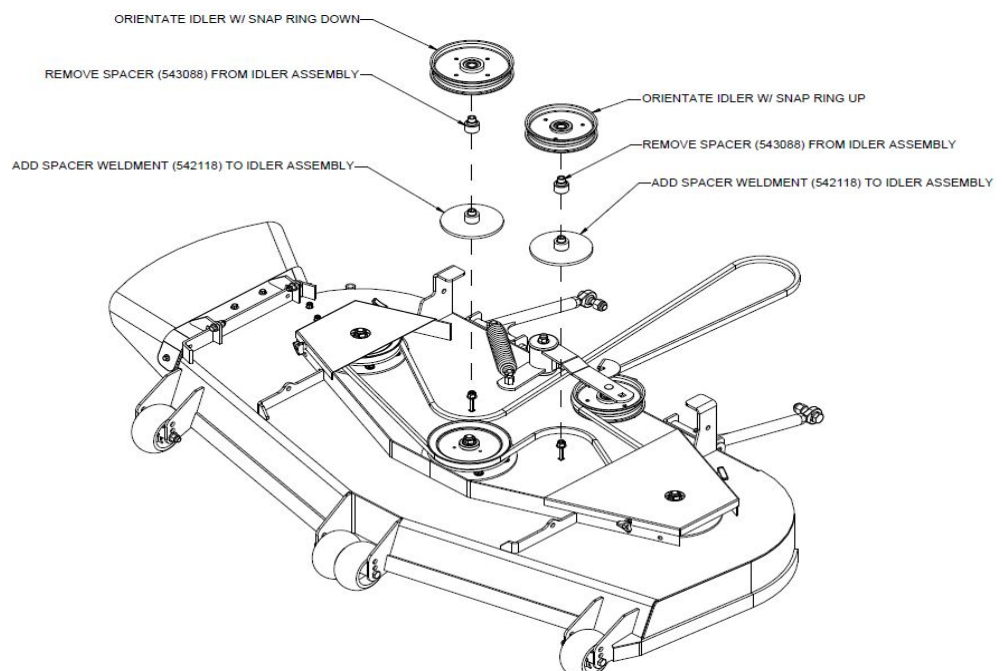
Situation: We had several field complaints on units with low hours where the deck has bent under the stationary idler pulley. When the deck bends the idler pulley may tip or lean over. The resulting misalignment may cause the belt to come off.

Solution: A reinforcement plate was added to all units in production and in inventory. All units in distributor, dealer, and retailed inventory should be updated as soon as practical. A kit was developed which contains two reinforcement plates, one for each of the stationary idlers.

Important Note The large idler needs to be installed with the snap ring on top. The small idler needs to be installed with the snap ring on the bottom
