# SERVICE NOTICE

Number: SN0307

Subject: X-treme 48, 52 and 60 unit below serial # 53686.

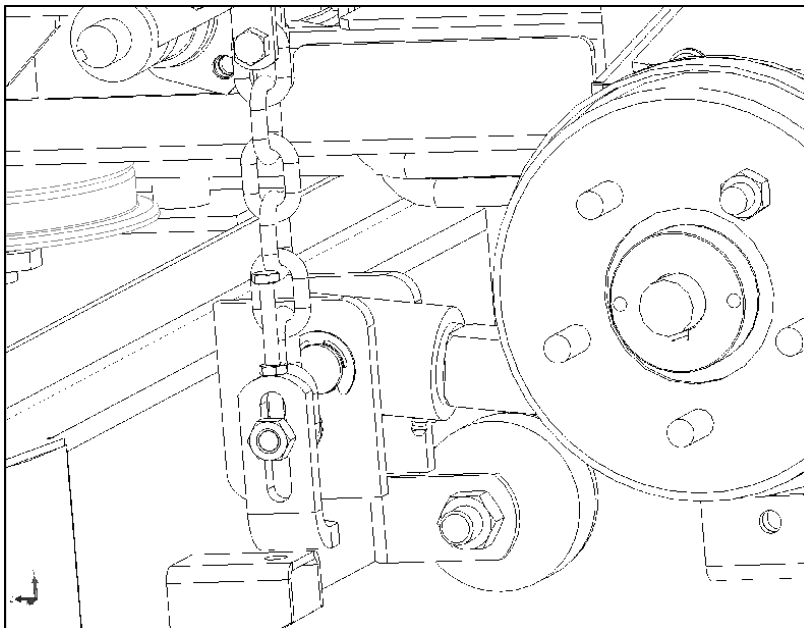
Details: When encountering hose damage on the X-treme Model you may remedy the problem by trimming the stand offs that are located to the rear of the deck. To do this raise the rear of the machine, making sure that it is secure, At this time remove the belt cover from the right hand side of the deck and roll the deck drive belt off of the spindle pulley. Now remove the rear tires and starting on the trim side or left hand side of machine from operators position remove the deck lift chain by removing the 3/8 bolt from the deck chain bracket. After doing this remove the straight grease fitting from the deck arm and replace it with the 90° grease fitting that is located in the rear of the of the deck lift arm tube assembly (just swap fittings). With that done now remove the cutter key from the support pin on the deck. Remove the pin and block the deck arm up, with a 4" grinder either cut or grind both deck arm stand offs to a 3/4" / 45° angle. After accomplishing this rotate the 90° grease fitting to the bottom side of the deck arm and replace the pin and cotter key. Reattach the deck chain bracket and repeat the procedure on the right hand side.

Replace the deck belt making sure the it is on all pulleys correctly, belt cover and replace the wheels.

If any hoses need to be replace please use part # 533089 outside and # 533090 inside lines. Note that hoses should be replaced while the wheels are removed.
