SERVICE BULLETIN

Number: SB9523-20

Subject: Thumb Latch on Encore Hydro Walk-Behinds

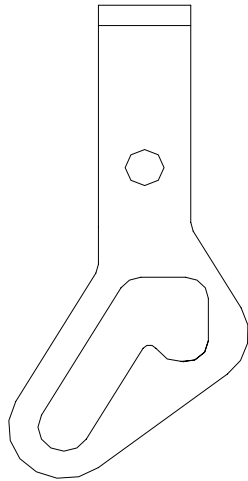
"Old" Belt Drive

It may be possible that a few of the Hydro's may have been sent out with the old belt-drive thumb latch. Please check your upper handle assy to see that the right one has been installed. Refer to the example below. If you have the wrong latch, you will have difficulty setting neutral without going to reverse when going to neutral with the thumb latch.
