SERVICE NOTICE

Number: SN0201

Subject: Shortening PTO Shaft

Procedure for Shortening PTO Shaft on Prowler Midcut

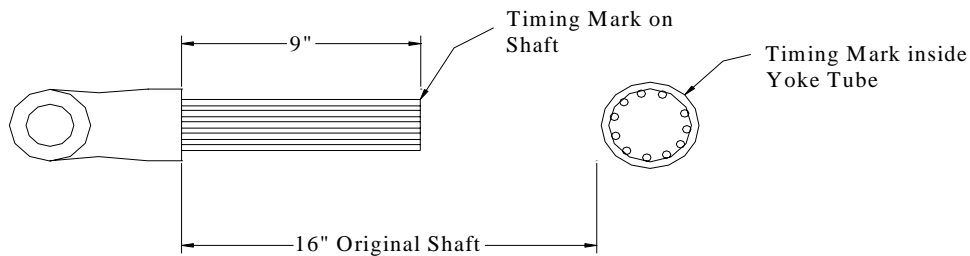
Original shaft splines are 16". Locate the timing mark on the splined shaft and measure back 7". Mark the shaft by crimping or spot-welding the timing splines so as to relocate timing splines after cutting off shaft. Cut shaft off leaving the remaining shaft 9" long. When cutting off shaft, make certain not to destroy the crimp or weld you made to discern the timing splines on the remaining shaft.

Shortening the PTO shaft is done on **Midcuts** only below serial #'s 40358. Units with serial #'s 40359 and above already possess the shorter splined shaft (part # 593064). When replacing a complete shaft on **Midcut** Prowlers, please order part # 593064.
